Zebra Mussel Abatement

Anne Lucietto
FESS/Ops - Engineering

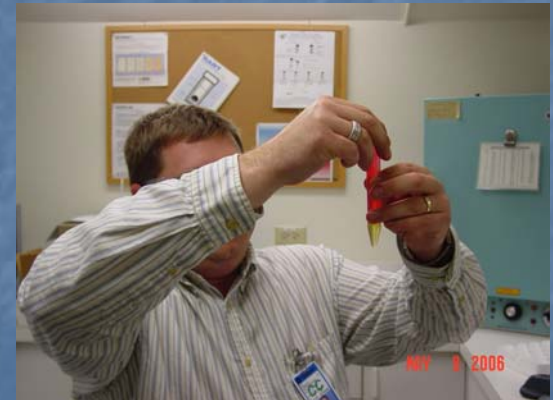
Realignment needed to achieve accurate dosing in:

- Main Injector
- Main Ring/Tev
- Area Near Cross Gallery

- 3 new hydrant flows introduced to induce accurate flow and dosing
- 60% increase in testing originally planned – to provide more data to benefit future treatment
- EVAC concentrations following this phase lower than anticipated (by 25%)
- Separation of shells progressing slower than anticipated due to lower water temps

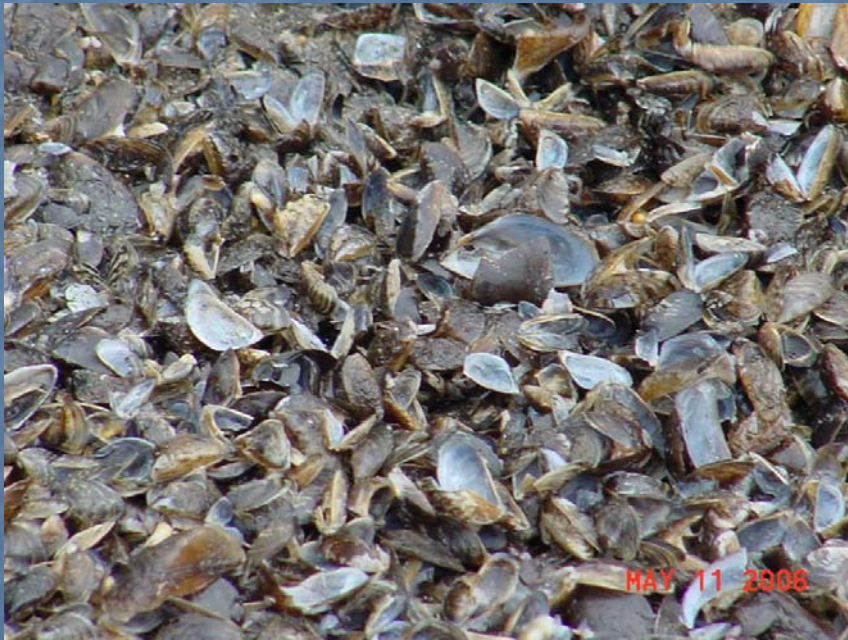
Begin/Continue Flush Until Cleared of Shells

- Pre-Flush department briefings
- 24/7 flushing by shop to minimize clogging
- Due to careful pre-planning and constant flushing no clogging occurred.

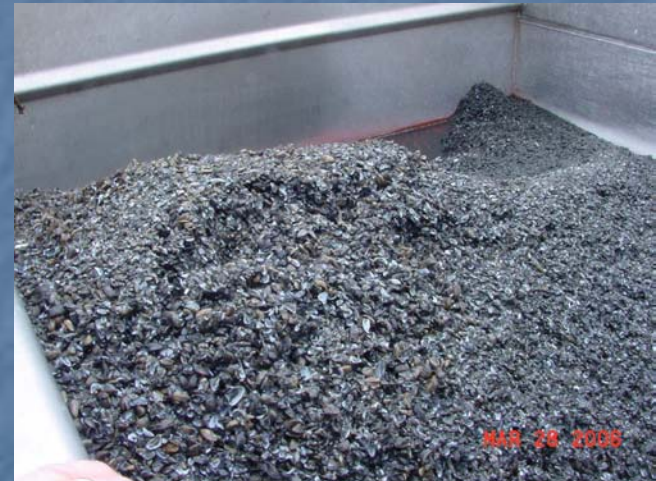
Results of Flush

3,000# removed from pipes
10,200# removed from intake

Heavy concentrations in:

- Fixed Target
 - Meson Central Cryo/LLRW
 - TPL
 - PB6 & PB7
 - Labs A-G
- New Muon
- CHL & IB1A
- Reflecting Pond
- Cross Gallery

- Smaller Shell Sizes at New Muon – somewhat uniform first flush
- Very large sizes found near Wilson Hall (5-6 years old)
- General mix in size throughout site
